AUTOMATIC INSPECTION SYSTEM FOR PIPING CORROSION

Yukio Kurosaki

Technical Research Institute
Research & Development Division
Mitsui Construction Co., Ltd.

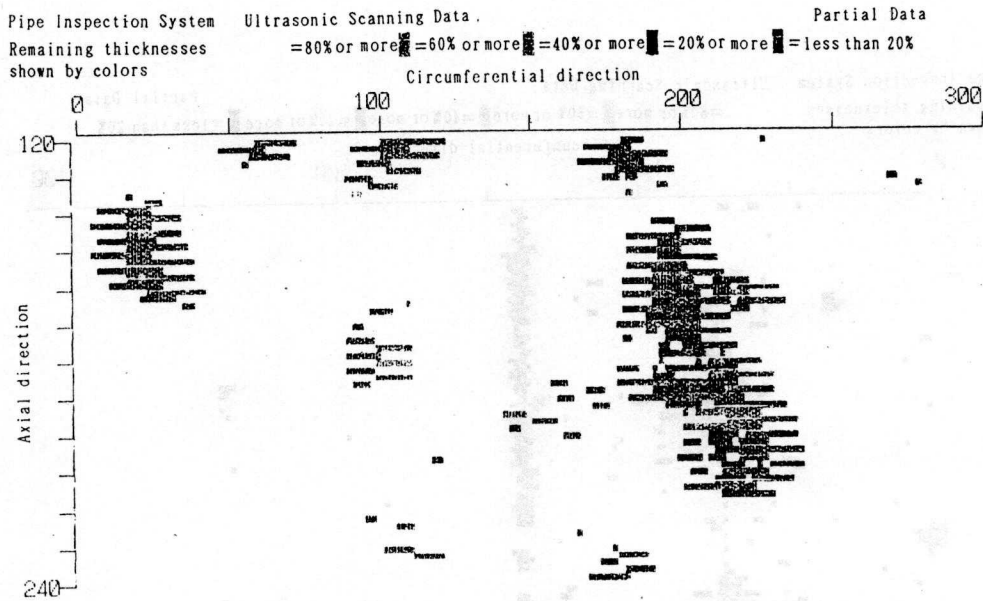
Fig. 6. Result of Measurement of A Water Pipe (N Building)

Table 2 summarizes measured remaining wall thicknesses of pipes (N building). Examples of outputs for measurements of water pipes (N building) and chilled water pipes (S building) with different deterioration patterns (corrosion patterns) are given in Figs. 6, 7 and 8. Results of inspection in N building shows that the remaining wall thicknesses of both hot-water and cooling pipes are 2.0 mm or more. It is thought,

from the lengths of periods during which these pipes have been used, that they are unlikely to pose any problems in the near future. However, remaining thicknesses of 0.84 mm or more and less than 1.68 mm were observed in 15 grid squares, indicating higher levels of local deterioration than in other pipes. This is because of the difference in corrosion patterns, and it is thought that there will be no problems for the moment, though some care needs to be taken. Results of inspection in S building show different patterns of corrosion in different parts of pipes of the same type (chilled-water pipes).

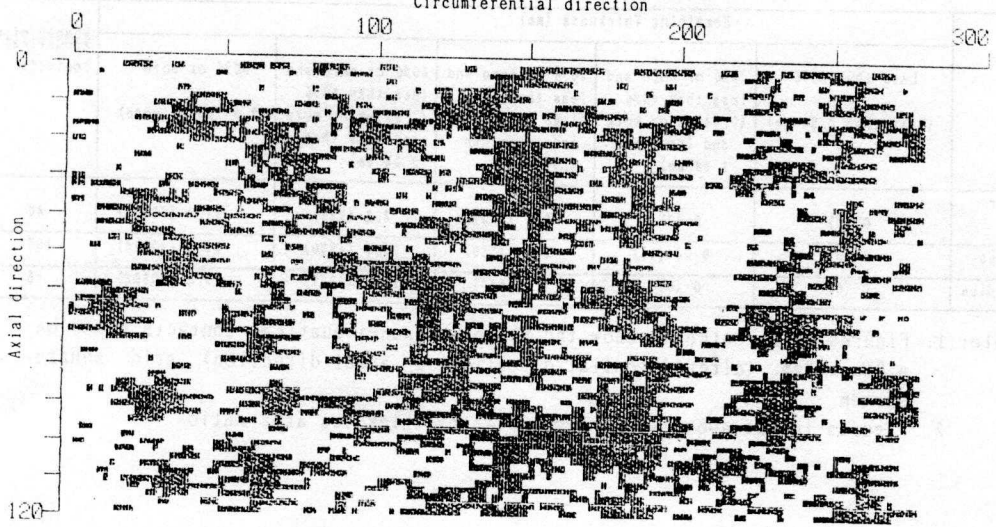
Fig. 7. Result of Measurement of Chilled-Water Pipe A (S Building)

Fig. 7 shows a pattern of evenly distributed, considerable corrosion on the exit side of a cooling tower. The minimum remaining wall thickness is 1.6 mm, indicating the need for some quick measures. Fig. 8 shows deterioration on the exit side of a pump. This figure shows a mixture of a groove-like distribution of corrosion at the electro-resistance-welded joint and a localized distribution of corrosion nearby. The minimum remaining thickness is 2.1 mm, which also requires some kind of measures, as with the pipe on the exit side of the cooling tower.
