THE CHARACTERISTICS OF SURFACE RUPTURES AND LANDSLIDES IN THE CHI-CHI EARTHQUAKE OF SEPTEMBER 21TH, 1999

Keyword: The Chi Chi Earthquake, Surface Rupture, Landslide

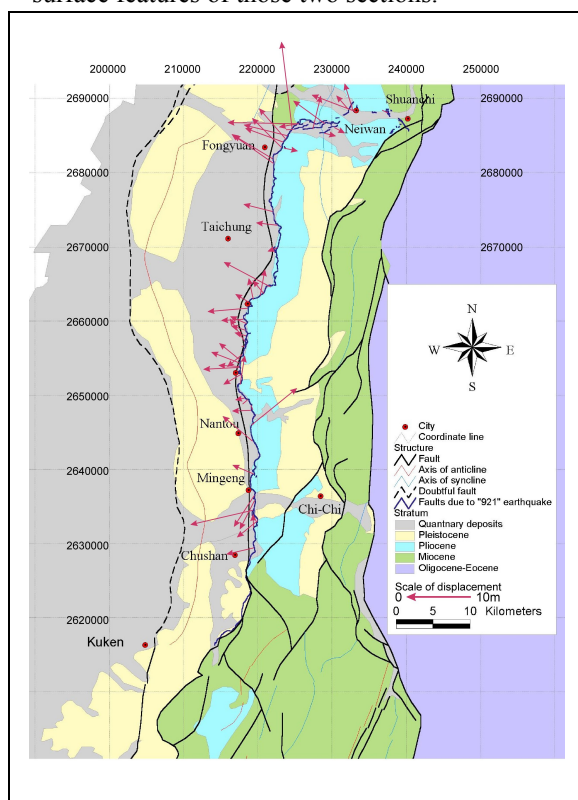
Fig 1. Geological map of central Taiwan, dark blue line represents surface rupture and red arrow show the plane vectors of offsets.

The offset in south-north section from Kuken to Fongyuan was several centimeters from south to 3 meters near Chushan in north, then reduced to 1 meter near Chung-Hsin new village, and increased to 2~3 meters in Wufeng and Taiping city. It increased gradually from here to north; the largest difference was 6.7

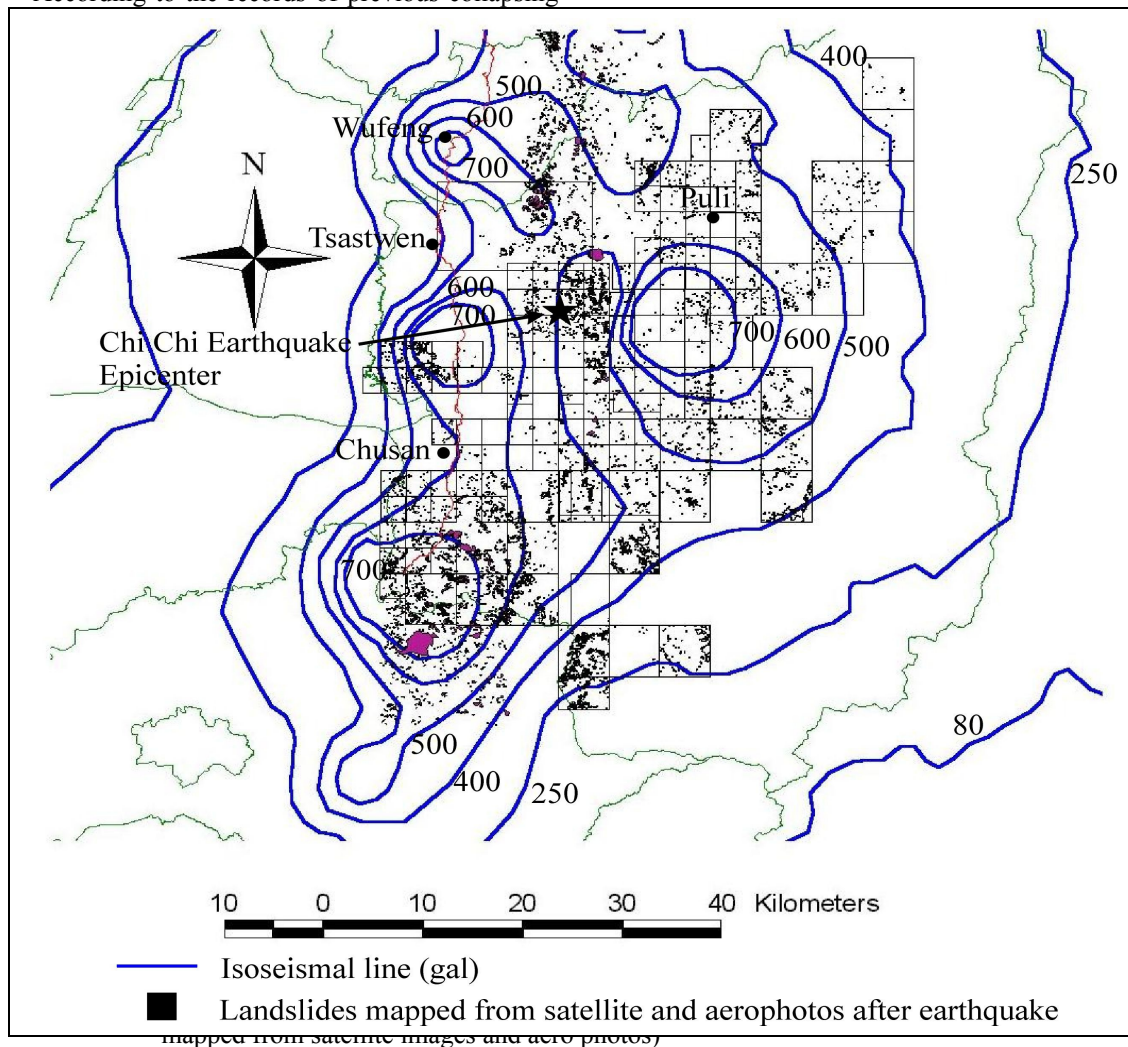
. According to the combination of the satellite changing points information of Nantou County after 0921 earthquake provided by Water

Reserve Bureau of Agriculture Committee and the aerial photo of the collapsing distribution drawing after 0921 earthquake by the Disaster Prevention Center came out the result as shown in Fig.2. The surface quake vibrations were not evenly distributed due to the influences of topography, geography and underground structure, the quake vibration in Tsaoling, Minggeng, Wufeng and Dili areas were the

highest. The mountain area of those places had intensive collapse and in accord with the foreign relevant results; which will be the continuous observation locations in the future. The major difference between the collapse caused by earthquake and the collapse caused by deluge is the higher the elevation is, the speeder the surface acceleration will be, therefore, most of the collapse caused by earthquake happened near crest line.
