Preliminary Study on Enhancing Detection of Concrete Bridge Surface Spalling by Infrared Thermography

Ching-Wei Chen ¹, Hui-Ping Tserng ¹, En-Wei Chiang ¹

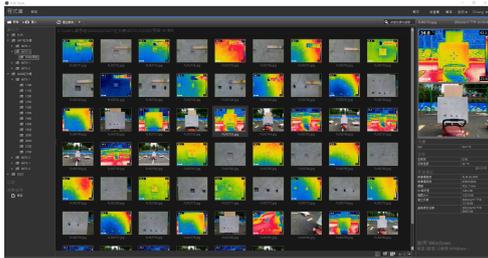
Figure 1. FLIR tools/tools+ software screenshot

The temperature data acquisition through thermal imaging will be performed using FLIR tools to obtain the average temperature of the defect (T_i) and the average temperature around the defect (T_S). The steps are as follows:

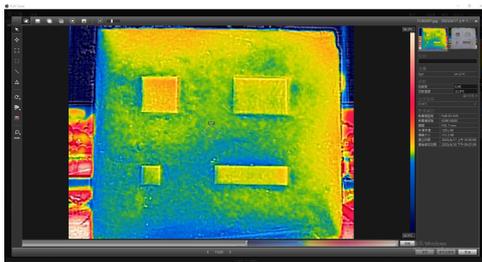
Figure 2. FLIR tools/tools+ Software editing model

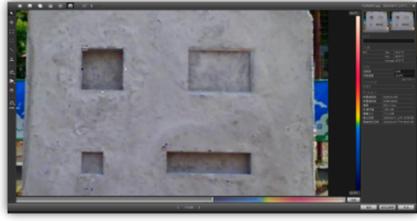
Figure 3. Example of selecting defect temperature value in the visible light image

- (1) Import the desired image into FLIR tools (using defect number 1 for demonstration purposes). Double-click to open the image and enter the operating interface. Switch the image mode to digital thermal camera (visible light image).
- (2) In the visible light image within the digital thermal camera mode, use the temperature measurement function to select the area of the defect for measurement. This action will yield the average temperature of the defect. For demonstration purposes using defect number 1 from the first set of specimens (refer to Figure 3), the average temperature (T_1) of defect number 1 (Bx1) is measured to be 42.5°C.

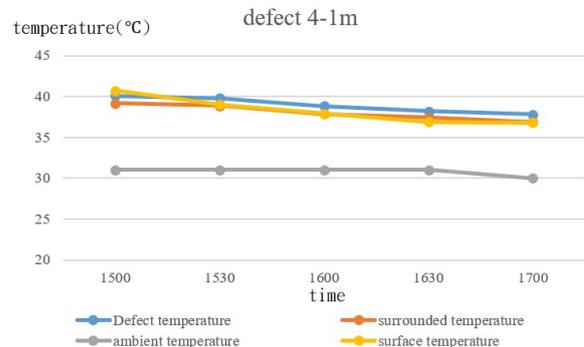
Figure 6. The line graph for defect number 4 of the third set of specimens, taken at a distance of 1 meter on the thermal image between 3:00 p.m. and 5:00 p.m.

In both the first and second phases of the experiment, the research results will be presented using line graphs (as in Figure 6) and pie charts (as in Figure 7). The third stage will involve the use of line graphs and bar charts for discussion purposes. For on-site bridge inspections, discussions will be presented in tabular form. The following is a summary of the three stages of the experiment.
