Measuring Adhesion Strength of Wall Tile to Concrete by Non-Contact Inspection Using Electromagnetic Waves

Keywords – Non-contact inspection; Electromagnetic wave; Adhesion strength; Multi-layered scanning.

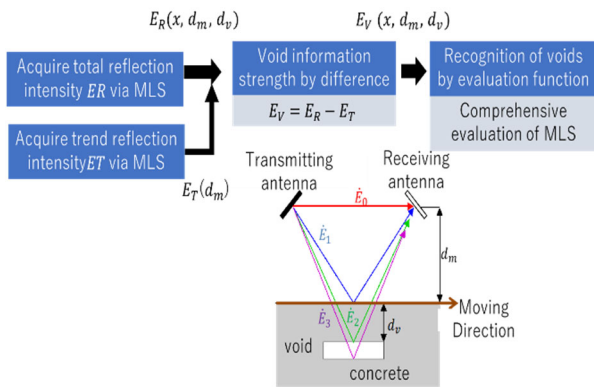
Figure 5. Algorithm for void detection.

The detection void algorithm is shown in Figure 5. First, the total reflection intensity, E_r , is measured by MLS. In abnormal areas, the received intensity is the effective value of the sum of the direct wave, surface wave, and air gap reflected wave. Next, the trend reflection intensity, E_t , is measured by MLS. This shows the reception intensity of normal (void less) areas, which is the effective value of the sum of the direct wave and

the surface wave. Then, void reflection intensity E_v is obtained by taking the difference between the total reflection intensity and the trend intensity strength. The last step recognizes voids by a comprehensive evaluation of MLS.

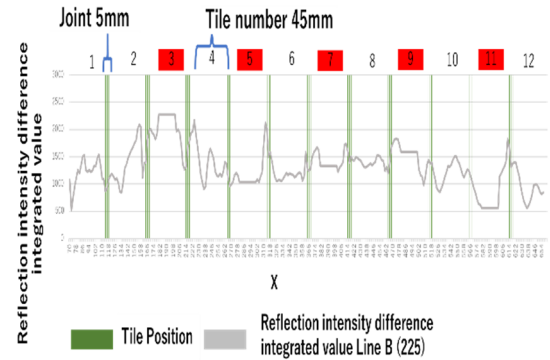
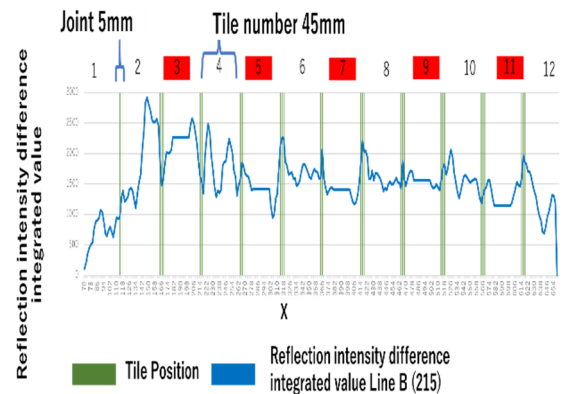
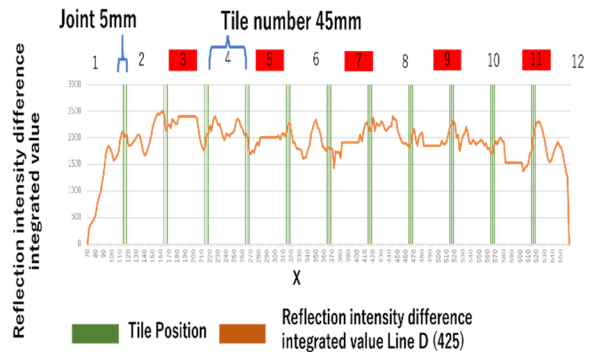
Figure 7. Distribution of $P(x)$ at various tile locations.

(a) $y = 215$ mm (Line B 225).

(b) $y = 225$ mm (Line B 215).

(c) $y = 415$ mm (Line D 425).

(d) $y = 425$ mm (Line D 415).

Experiments were conducted using real tiled concrete to demonstrate the effectiveness of the proposed method for inspecting actual tiled walls. The concrete specimen shown in Figure 3 comprises the tile, its adhesive mortar, and concrete. MLS was performed at $y = 215, 225, 415,$ and 425 mm, with a measurement area as shown in Figure 6. Intensity $E_R(x, d)$ was obtained by scanning along the x -axis in each scanning area several times at intervals of $60 \text{ mm} < d < 90 \text{ mm}$. through changing y -axis, we can set up the Anita in position of Line. The evaluation function $P(x)$ using this result is shown in Figure 7. The vertical axis shows the variation of the integrated reflection intensity, which varies according to whether voids are present. The average integrated reflection intensity was taken at a distance ± 10 mm from joints. The horizontal axis is the tile position. Red tiles have voids ranging from 30% to 100% of the tile size. Other tiles are normal tiles without voids. In most scanning lines, the integrated reflection intensity is high at large voids and low at small voids.

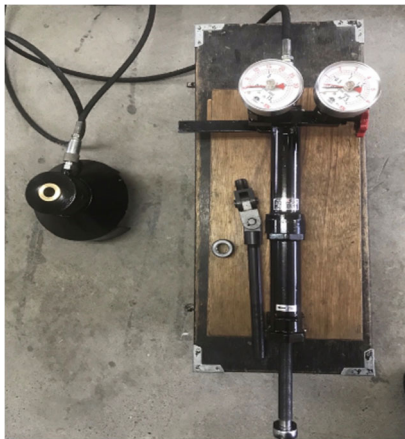
Figure 8. Manual Pull-off adhesion tester.

Measurement of the adhesion strength was demonstrated using a pull-off adhesion tester (LPT-3000, Ox Jack Co., Ltd.). Before using the adhesion tester, a hammering test was performed to determine whether a void was present. Figure 8 shows the tester, which

consists of an analogue load cell, a pump handle, and an attachment. When the pump handle is turned clockwise, the attachment rises and pulls the tile until it separates from the concrete, as shown in Figure 9. At the moment of tile removal, the strength is measured by the load cell and recorded. The recorded load data are shown in Table 1, columns 3 and 4.

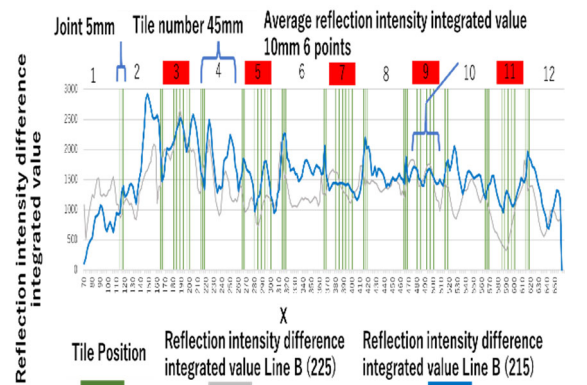
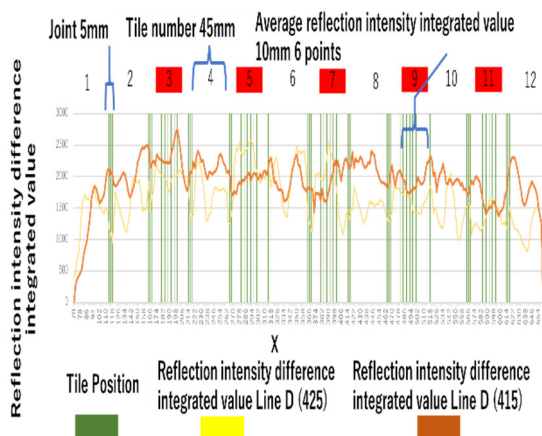
Figure 10. Distribution of tensile bond strength.

Figure 10(a) and (b) show the values of exact value of $P(x)$ of all lines at locations of each tile for which adhesion strength was tested. The six points of $P(x)$ was taken over a total distance of 20 mm and ± 10 mm from joints to avoid effects from the joints themselves [6]. The points were distributed on Lines B 215, B 225, D 415, and D 425. Data recorded from the tile pulling tests and MLS analysis are shown in Table 1. Column 1 shows the location of each tile for which adhesion strength was

tested and MLS was performed. Column 2 is the void size, which varied from 30% to 100% of the tile size in 20% increments. Column 3 shows the recorded pull strength data in kilonewtons, which is the power required to remove the tile and is directly analogous to load cell results. In column 4, the power is converted to newtons per square millimetre. MLS results are shown in column 5. Based on the adhesive strength and MLS data from Figure 10(a) and (b), Table 1, the scatter plot in Figure 11 was created. This plot shows the adhesive strength of all lines on the horizontal axis and integrated reflection intensity on the vertical axis. The intersection of the two values is shown by colours indicating the tile and scanning position.

seen in Figure 10(a), in Line D 425, tile No. 3 has a void size bigger than that of No. 5. Therefore, it should have a higher intensity value. However, the integrated value for reflection intensity difference is lower. In Line B, tile Nos. 7 and 8 have the same issue. These issues might have occurred because the tiled concrete specimen was not cured. Environmental effects on sheet strength due to the time that elapsed between performing MLS and measuring the tensile strength needs to be taken into consideration. To improve the accuracy of the estimation, more data are needed by analysing tiles of different sizes. In addition, the experimental procedure would be improved if the MLS scanning data and the adhesive strength were obtained at the same time. Furthermore, a more accurate adhesive strength measurement device should be used.

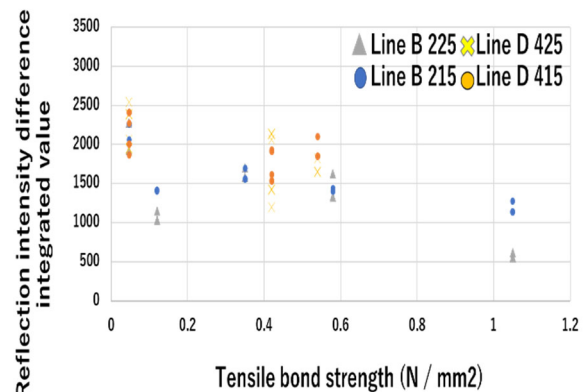
Figure 11. Reflection intensity integrated value versus tensile bond strength

The results of adhesive strength measurements plotted against MLS values in Figure 11 indicate that there is a negative correlation between adhesive strength and the value of the tensile strength. Also, there appears to be a linear relationship between the two variables. Testing of the significance of the correlation coefficient confirmed a strong negative correlation, meaning that a decreased tensile bond strength is correlated with increased integrated reflection intensity, with $R = -0.622$ at $p < 0.001$. Furthermore, regression analysis provided the result $R^2 = 0.382$ at $p < 0.001$.

The results show that this method can estimate the adhesion strength, but with a large error. The regression analysis R-squared result is significantly low. This low value might be caused by the experimental procedure, or it might indicate that there was a problem in how voids were implanted under the tile to make the specimen. As
