Report on the Measurement of the Form of SHOTCRETE GRID BEAM-FREE FRAME Using Point Cloud Data

Takayuki Kojima^a and Yori Nomoto^b

^{a,b}East Nippon Expressway Company Limited Yuzawa Management Office, Japan
E-mail: t.kojima.ad@e-nexco.co.jp, y.nomoto.aa@e-nexco.co.jp

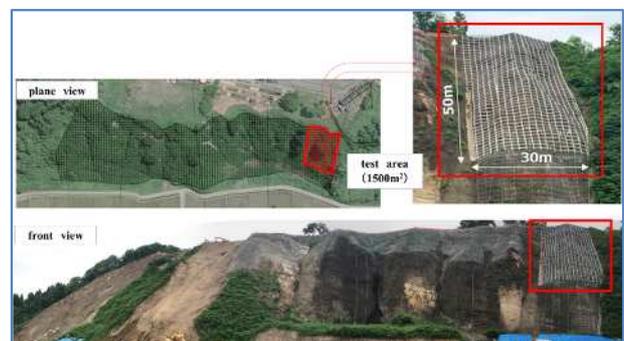
Figure 2. Test Area (50m×30m)

The glue surface here had collapsed due to heavy rainfall in July 2017, to restore the disaster, we planned and commissioned the reinforcement using sprayed method frames and Tests were conducted as part of this work (test area was about 50 meters high and 30 meters wide).

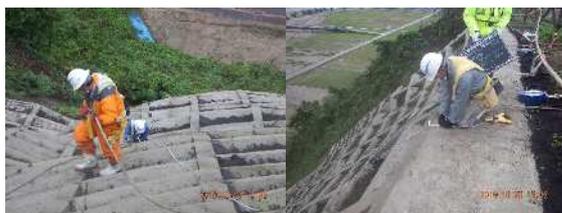
Figure 6. Status of surveying works

Surveying by UAV of the workpiece (per 1500m²) requires more off-site work than actual measurement (tape surveying). The reduction is about a quarter. However, the total reduction effect is about half due to the increase in internal work such as analysis work. As shown in Table. 3, the work was performed on a steep slope, and the use of the UAV made the work site safer. In addition, we have improved in the following areas.
