WORKER HAZARD MANAGEMENT OF BUILDING DEMOLITION

Abstract: The Ji-Ji earthquake was the most damaging earthquake that Taiwan has ever suffered over the past century. In addition to mountain collapses, landslides, fault slippage, bridge ruptures, and roadway buckling, tens of thousands of buildings were also crushed by the powerful force of the earthquake. In the Ji-Ji earthquake, the most serious damaged infrastructures were building structures. Generally speaking, there were four major reasons that contributed to the damages of the large number of buildings--the strong intensity of the earthquake, the poor architectural design of the buildings, the poor structural design of the buildings, and the poor quality control during the buildings' constructions. After the earthquake, due to the urgent needs to rescue survivors, there was not enough time to implement safety measures for demolition related activities. However, we can not ignore the possibility of occupational injuries and endanger the rescue workers. Therefore, we investigate the workplace safety issues related to the emergency rescue operations after the earthquake. It is hoped that this information can be used by the autho

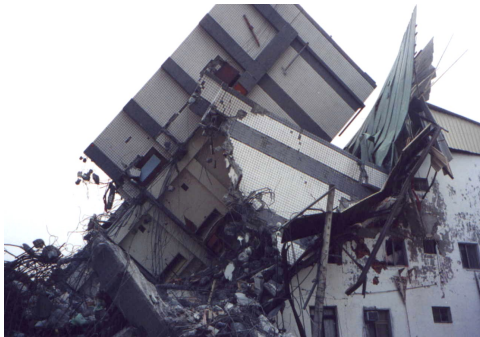
After heavy rains, the already partially collapsed Da-li-wang-chao building in the Taichung City became dangerously tilted and displaced. Since the building was only temporarily supported by five steel beams, it subsequently collapsed when the building demolition was in progress on April 23, 2000. The collapsed building crushed into the four-story apartment building across the street.

Picture 1. The Da-li-wang-chao building in the city of Taichung collapsed and hit the adjacent building (Photo credit: Chung-Wei Chen, Dept. of Civil Engineering, National Taipei Univ. of Technology)

1.2 The Da-li-wang-chao building in the city of Taichung collapsed during demolition (picture 1)

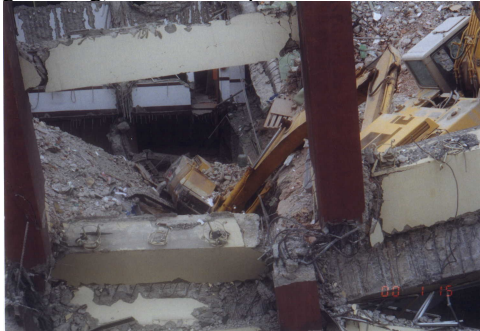
When the ADI Corporation in the Taiping City was demolishing a partially collapsed building on January 10, 2000, an excavator and its operator were buried by collapsed rubbles from above. The operator died as a result.

Picture 2. The demolition of the ADI Corporation's factory building

1.3 An excavator and its operator were buried during demolition in Taiping City of Taichung County (picture 2)

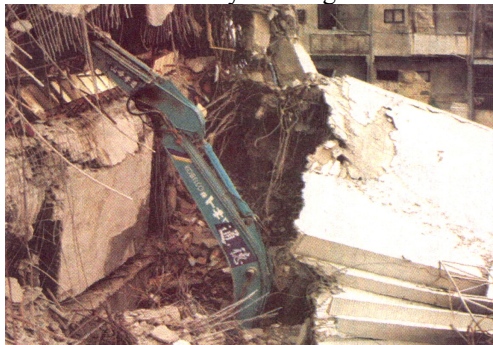
There have been fire reports during the demolition of the A-li-shan Opera Theater, which started at the end of March of 2000. When the demolition proceeded to April, the slab of the 4th floor suddenly collapsed. Two excavators fell onto the ground. One of the operators of the excavators escaped with terrors, and the other was seriously injured because he was pierced by steel bars protruding from the floors.

Picture 3. The demolition of the A-li-shan Opera Theater

1.4 The floor of the A-li-shan Opera Theater (Jungpu Shiang of Chia County) collapsed (picture 3)

Carefully analyzing the above accidents, it is easy to see that the main cause for the accidents is the contractors' lack of professional knowledges of structural engineering. For example, according to the structural analysis, the maximum moment is $1/24 WL^2$ when a continuous floor slab is subjected to an equally distributed load. (Please refer to Fig. 1, where W is the equally distributed load, and L is the distance.) If the two ends of the slab are no longer continuous due to damages caused by the earthquake, the maximum moment will increase to $1/8 WL^2$, three times the previous value. The ADI corporation and the owner of the A-li-shan Opera Theater did not take this into account. Therefore, the floors collapsed when heavy machinery operated on the damaged floor, and caused the accidents.
