# THE SEARCH AND RESCUE OPERATION IN COLLAPSED BUILDINGS CAUSED BY EARTHQUAKES--A CASE STUDY

**Abstract:** This paper uses the experience from the search and rescue operation at the Dong-Xing Building, which collapsed in the Ji-Ji Earthquake, as a real example to study the risk factors that contributed to the deaths of the residents of the collapsed building. This paper also examines a possible strategic plan to rescue survivors from collapsed buildings, which combines various sources of information such as water mains, fire-fighting equipment, shelter locations, medical facilities, household registry information, lifelines, logistic supports, and the disaster management technology.

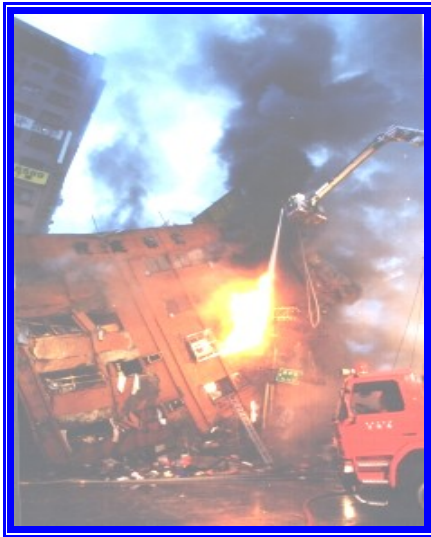
Commercial Bank, the 3<sup>rd</sup> to the 10<sup>th</sup> floor were apartments, the 11<sup>th</sup> & 12<sup>th</sup> floor were the Sung-Shen Hotel, and the basements were used as parking garages. After the Ji-Ji earthquake, the building tilted toward the east side and collapsed with the northeast corner being the worst part of the building. The floor slab of the 8<sup>th</sup> floor collapsed down to the ground. The weight of the building also squeezed the west side and the basement. The 6<sup>th</sup> floor on the southeast corner also leveled to the ground, compressing the floors between the first and the 6<sup>th</sup> floors. On the west side, floors above the 9<sup>th</sup> floor (included) tilted severely (between 45 and 60 degrees), and floors below the 8<sup>th</sup> floor (included) were brutally crushed. But, the first to the third floors on the southwest side were still intact. On the east side across the street from the Dong-Xing Building, the Hao-men-shih-chia Building were hit and squeezed by the tilted Dong-Xing Building, causing severe damages on the columns, beams, and walls between the 2<sup>nd</sup> and the 7<sup>th</sup> floors. Finally, the 12<sup>th</sup> floor of the Dong-Xing Building was sheared off and fell between the 3<sup>rd</sup> and the 4<sup>th</sup> floors of the Hao-men-shih-chia Building.

As mentioned, the Dong-Xing Building tilted toward the east side after the earthquake. The 1<sup>st</sup> to the 8<sup>th</sup> floors were crushed, and the building structures were distorted and deformed. Forty

Picture 1. The collapsed Dong-Xing building.

The Dong-Xing Building was distorted and crushed by the strong shaking of the earthquake. The fire department immediately dispatched 51 fire engines, 12 ambulances, and 309 fire fighters to the site of the collapsed building (Picture 1).
