# Applicability of Laser Scanning to the Measurement of 3-D Terrain Model for Street Design

**ABSTRACT:** This paper describes the first results of R&D project "Intelligent Street" carried out in Finland. The aim of the project is to develop new measuring and design methods and tools for street design and construction. Usability and accuracy of laser scanning technology was tested in field-tests done in Itäreimarintie street pilot in Helsinki area June 2003. Implementations of measurements using helicopter based 3-D laser scanning technique are presented and evaluated. Terrasolid Ltd. software products for laser data processing was developed and tested in this project.

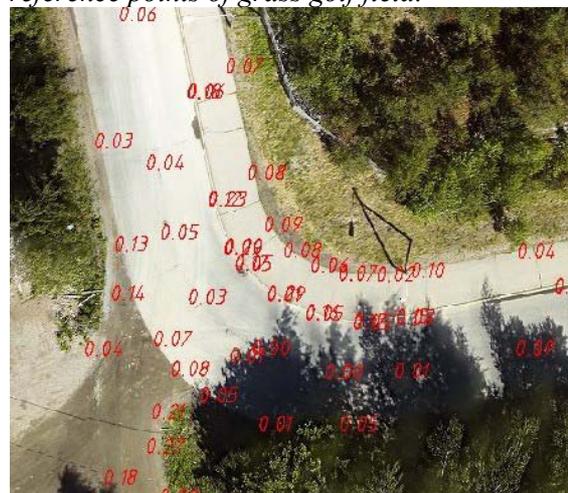
Figure 4. Measurement area 3 - reference points of the road.

First area is forest area near street resort. Second reference area is constructed area and third area is asphalt road. Fourth area is grass and partly sand field. Photos of the reference areas with some Z-difference measurement results are presented in pictures 2-5.

The results of the tests in measurement areas 1, 2 and 4 were that laser-DTM average systematic Z error was between five to ten centimeters above the ground. At first measurement results measurement area 3, asphalt road, average systematic errors sign was different than other areas. DTM of the area 3 was about seven centimeters below the ground, which gave a reason to distrust correctness of the measuring values. Flight strips in question was checked and the reason for deviation was found to be banking of the helicopter in that spot. After the failed strip data was removed, average systematic error was at same level as in other areas. Look results at table 2. After correction process average deviation of laser-DTM in all four areas was found to be 6,6 cm above the ground truth. Standard deviation (RMSE) of all test measurements was 9,1 cm.

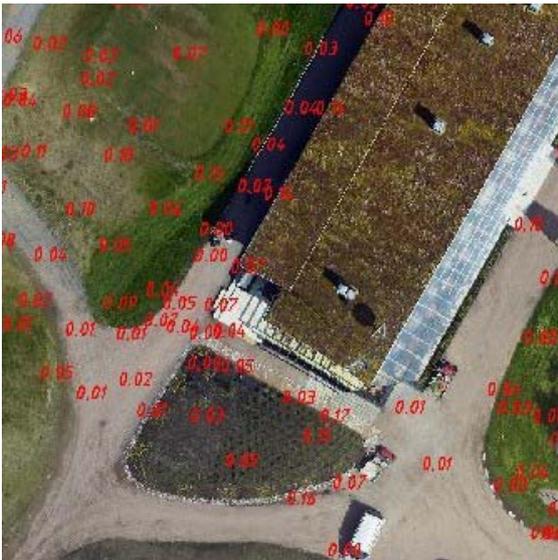
Figure 5. Part of the measurement area 2 - reference points of the buildings and roads.
