# Automation at the Westerscheldt Tunnel

**Ir. R.de Leeuw**

**Ir. E. Oele**

**ABSTRACT:** Terneuzen- On the 14th of March 2003, the Westerschelde Tunnel was opened after a construction phase of five and a half years. The tunnel was constructed using modern technologies which were partially supported by software and other automated equipment. It's uncommon to use highly automated technologies in construction projects because the unique character of projects reduces the economic feasibility of implementing automated techniques. In this article the following automated techniques will be described: measurement systems to measure the deviations of the used segments and the positioning of the Tunnel Boring Machine (TBM), and monitoring techniques with regard to the temporary frozen soil, which will be described in this paper. The saturation diving technique will also be described. The first part of this paper deals with the scope of the project and specific experiences gathered during the construction phase. The second part will deal with the automation techniques used will be described and finally a presentation of the conclusions will be made.

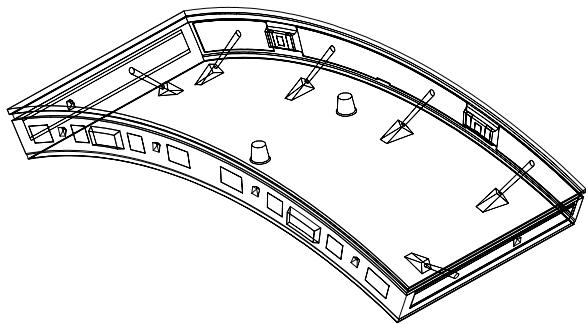
Figure 3: 3D image of a segment

Due to the low tolerances of the segments, the requirements for the production system of the segments were high. The production system was intensively monitored by the QA department of the Main Contractor. Scrap had to be minimised, while the tolerances were decimals of millimetres. Angles had a tolerance of  $0.1^\circ$  degrees over a length of 2 metres! Many data had to be measured to decide if a segment is to be approved or rejected. Therefore it was necessary to purchase a highly sophisticated measuring system to cope with exacting demands. Due to the fact that approximately 130 segments were required to be produced each twenty four hours, the measure system had to be accommodated user friendly and above easy processing of the data.

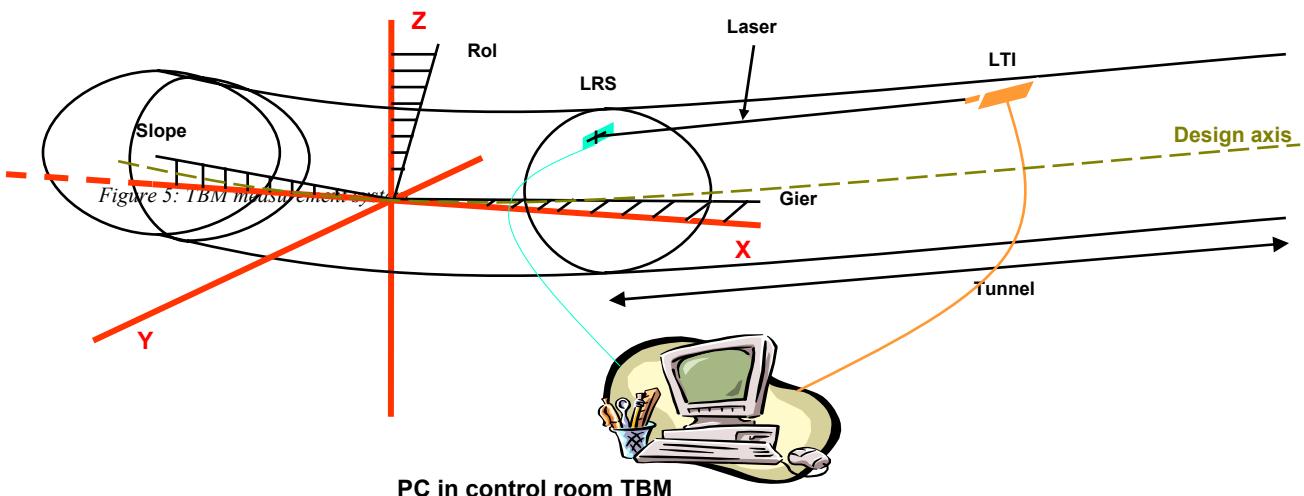
Another issue to be considered were the (potential) movements of the tunnel. When, for example, the fixed LRS at the TBM moves in one direction and the tunnel with the LTI moves in the same direction, it appeared that no deviations took place elsewhere. To eliminate these failures, the last part of the constructed rings was daily measured following a strict protocol:

- Each 50 rings; every three days before tunnel boring
- Each 20 rings; daily before tunnel boring

- Each 10 rings; every 3 days after the tunnel boring, to review the settling of the tunnel
- Each 4 months; review measurements to check the settling of the tunnel
- In the event deviations exceeded the accuracy, this period of one year could be extended

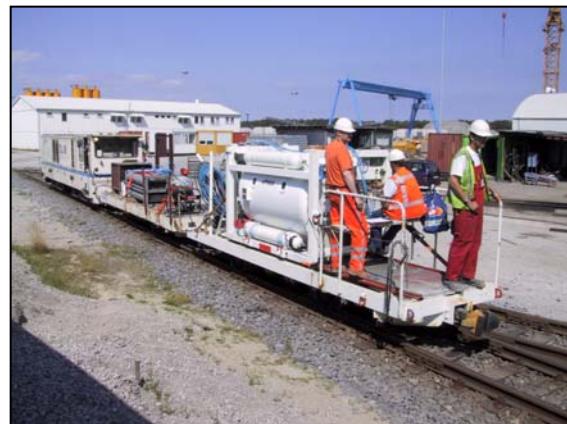
Figure 6: Transport Capsule to the TBM

decompressing is more time consuming than the increasing to local pressure, divers were transported out of the tunnel in a saturation transport capsule (l: 3.10 m; w: 1.50 m; h: 1.70 m) and shifted to a larger saturation space on site. On site two saturation tanks, provided with the primary needs for a living, was the recreation area for the divers when the other diving team was working. These tanks were under permanent control by medical specialists.

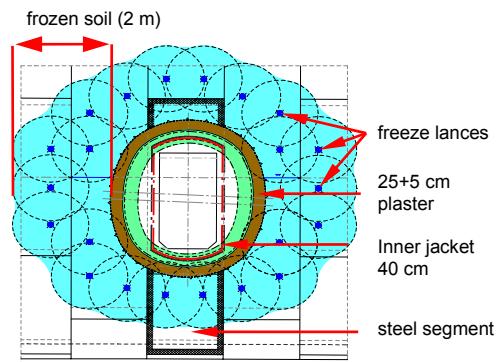
Figure 7: Frozen soil

Due to the limited length of these "tunnels", the link to the other tube was made by digging. Digging a hole in weak soil is only possible when the soil is temporary stabilised. There are different ways of stabilising soil and at the Westerscheldt tunnel, the soil was temporary frozen. To freeze the soil between the two tunnel tubes a kind of "heat"-exchanger must be temporary installed between the tunnels. To achieve this 22 freezing lances were drilled trough the segments in the soil

until they reached the other tube at a maximum distance of 20 cm. The internal distance between two lances was approximately 1 m. A liquid salt solution from -37° C was pumped trough the lances. The lance construction was designed to ensure that no chemicals would leak into the soil. The lances were drilled with an accuracy of 0.5%. Another restriction was that the drilling must be carried out with a miximum use of a half tunnel tube, to minimise disturbances to the logistics of the railway traffic. Besides the freezing lances two temperature lances and a de-watering lance were drilled as well. These temperature lances measured the temperature at two metres from the beginning of the frozen soil.

To reduce the increased water pressure, caused by the frozen soil, the de-watering lance was drilled. All lances were drilled from the Eastern tube.

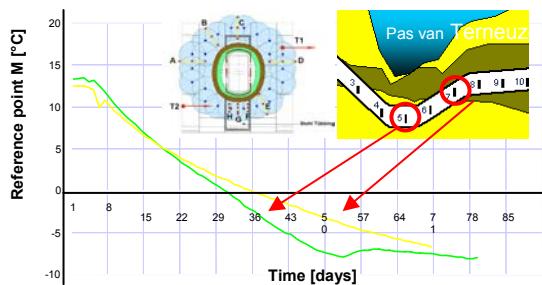
Figure 7: Freezing times

Cross passages constructed in Boom clay took more time to reach a 2 m thick Soil as cross passages in sand. The deeper the cross passage was constructed the less time it took to reach the necessary thickness.
