**DETECTION OF STREAMFLOW CHANGE TO PREVENT RESIDENTS FROM POTENTIAL
DISASTERS**

*J. -H. Chen, M. -C. Su, and J. Chen
National Central University
300 Jhongda
Jhongli, Taoyuan 32001, Taiwan.
(*Corresponding author: jhchen@ncu.edu.tw)

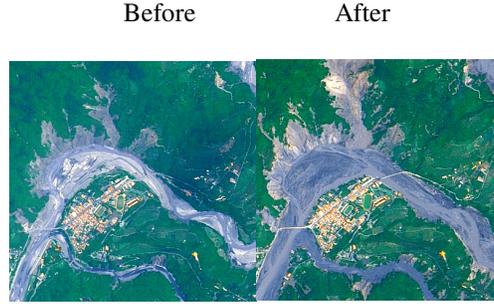
Figure 1 – Baolai-2 Bridge and its surroundings before and after Typhoon Morakot struck

However, no pixel is removed when satisfying $N(P) = 0$, $N(P) = 1$, $N(P) > 6$, or $S(P) = 0$, where the pixel represents the edge point. The proposed model is complete. Figure 4 presents a demonstration of the model interface using the C++ language. Applying the model to Figure 1 and then overlapping two courses, we obtain the result showing in Figure 5. The evaluation to measure accuracy is conducted based on manual check by experts. Figure 6 shows the evaluation results by experts and also a comparison of changes in the river width. Both manual and model recognition measures 88 meter erosion to the densest residential area. The results are relatively accurate based on the resolution of the images (± 8 meters). A measurement of 88 meter erosion to the densest residential area, which makes up almost $\frac{1}{4}$ of the area in width, represents significant threats to residents.

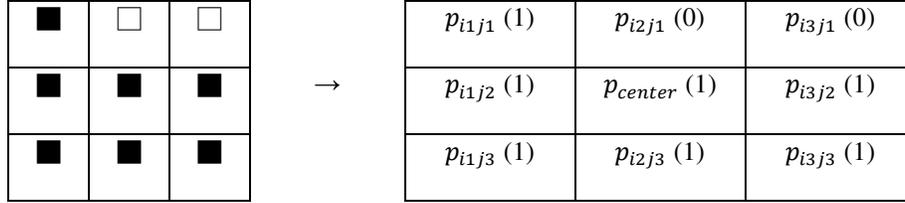
Figure 3 – Illustration for river skeletonization

Similarly the built-up area can be also estimated following this process. For river image recognition, there are two steps, dilation and erosion, to compute changes in the rivers. The dilation step finds any pixel in the river with its $I' = 0$ and then identifies its neighboring I' values in a smallest area (3 by 3). Once any neighbor with $I' \neq 0$ is spotted, the proposed model resets its value to 0. After a certain number of pre-determined iterations determined or no more pixel $I' \neq 0$ found, the dilation stops, and the next step of erosion kicks in. The erosion step is similar to a reversed process of the dilation step designed to restore the original river pixels without noise. In this step, the proposed model seeks those pixels being “dilated” in the last step. Finding a “dilated” pixel with $I' \neq 0$, the proposed model sets all $I' = 1$ when spotting any $I' = 0$ in the smallest neighbor area. This step is repeated until the pre-specified number of iterations is reached or no more $I' = 0$ pixels are found. Now, the river width can be calculated. The proposed model also measures river changes. Heavy precipitation may trigger landslides or flooding that presents similar images, which causes difficulty for recognition. The additional function of skeletonization provided by the proposal model outlines the main river course, detects new stream courses, and differentiates flooding or landslide areas. These tasks can be done through the determination of the river’s “skeleton”. Assuming that in an M by N neighboring pixel area, we define $N(P) = \sum_{i=1; j=1}^{i=M; j=N} p_{ij} (1)$ and $S(P) = \sum_{i=1; j=1}^{i=M; j=N} p_{ij} (0)$, as illustrated in Figure 3. To facilitate computation, M and N are usually set to be a smallest neighbor area (3 by 3). All pixels in the area are removed if satisfying

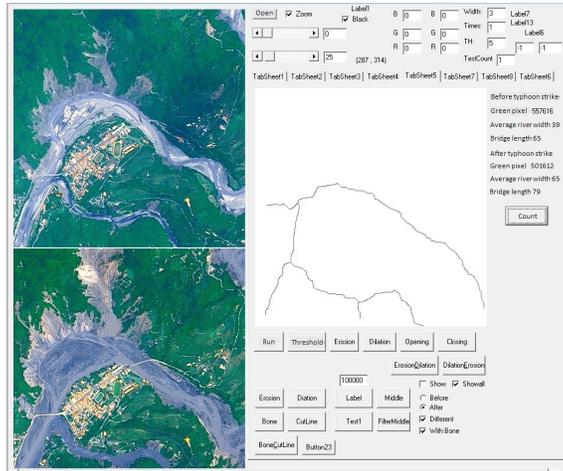
Figure 4 – River course and results

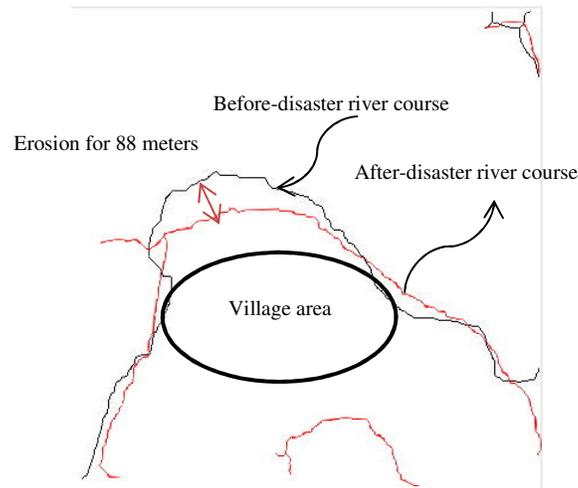
Figure 5 – Results for course change

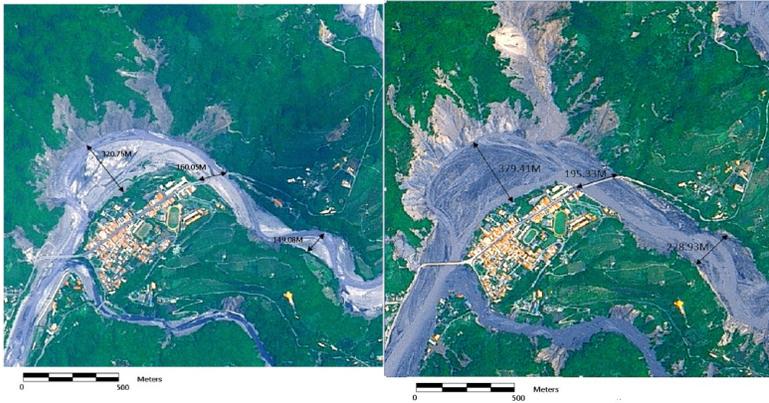
Figure 6 – Comparison of changes in the river
