# **Detection of Internal Defects in As-Built Pipelines for Structural Health Monitoring: A Sensor Fusion Approach Using Infrared Thermography and 3D Laser-Scanned Data**

**H. Son, C. Kim, and C. Kim**

Department of Architectural Engineering, Chung-Ang University, Seoul, Korea

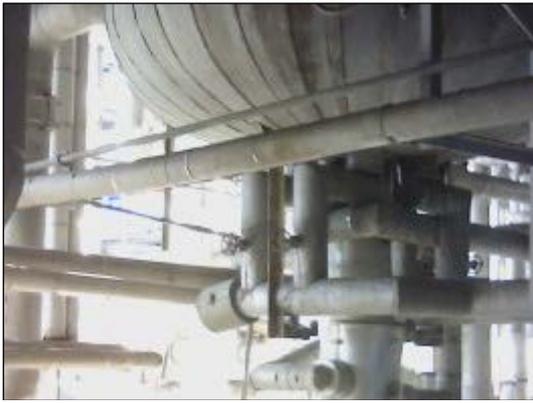
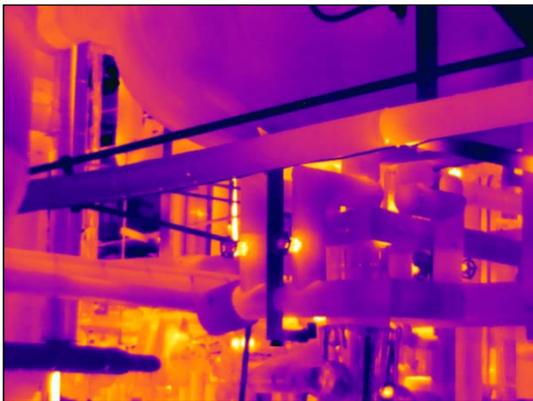
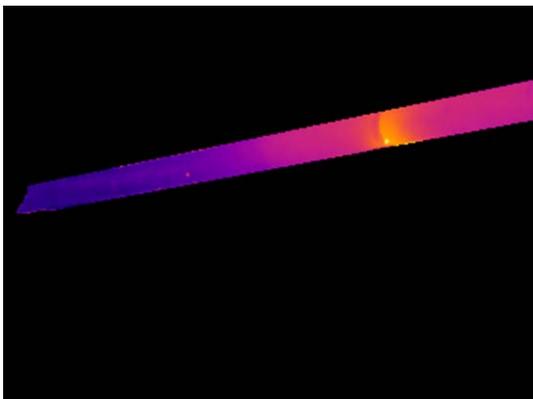
Figure 6. Scene 2: (a) Colored laser-scanned data, (b) Infrared thermography mapped onto the corresponding 3D points in (a), (c) Example of a recognized pipelines' thermal data having a defect along the longitudinal axis (minimum thermal value:  $5.38^{\circ}$ , maximum thermal value:  $38.22^{\circ}$ )

Figure 6(a) shows some portion of the colored laser-scanned data, and Figure 6(b) shows infrared thermography mapped onto the corresponding 3D points in Figure 6(a). Figure 6(c) shows an example of a recognized pipeline's thermal data having different thermal values along the longitudinal axis of the pipeline. Here, thermal values constituting the pipeline ranged from  $5^{\circ}$  to  $38^{\circ}$ .

The proposed approach reported heat losses revealed in the bright parts in Figures 5(c) and 6(c), but these defects were otherwise hard to identify using the naked eye. The experimental results demonstrated that the proposed approach has the potential to automatically detect internal defects in as-built pipelines from infrared thermography combined with 3D laser-scanned data.
