# Case study: Robotic Underwater Inspection of Concrete Dam Face Prior to Refurbishment

Frédéric Nadeau<sup>1</sup>, Marion Nourry<sup>1</sup>, Guillaume Boivin<sup>1</sup>, Eric Boudreault<sup>1</sup>, and Carmin Drolet<sup>2</sup>

<sup>1</sup>Hydro-Quebec, 1800 boul. Lionel-Boulet, Varennes, QC, Canada

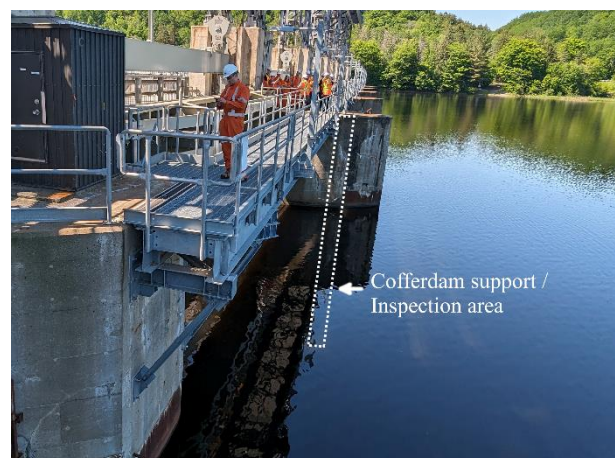
Figure 1. La Gabelle dam, upstream view of the concrete piers and inspection areas.

Hydro-Québec has many hydroelectric generating stations and spillways, some of which were built more than 100 years ago. Our case study focuses on the La Gabelle dam (Figure 1) that celebrated its 100th anniversary in 2024. It has reached a point in its life cycle where some maintenances must be planned. To target the right intervention to restore the life of mechanical equipment and concrete structures, it is important to have quality data that is sufficiently representative of their condition.

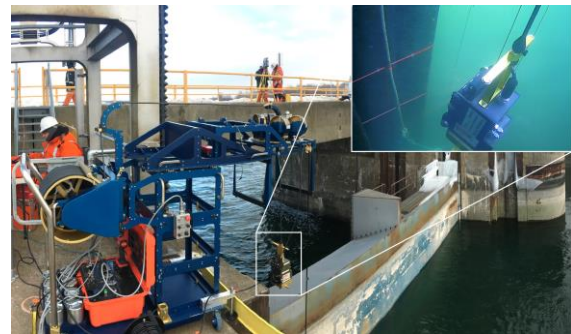
Detecting damage on submerged structural elements is often challenging, especially when precision is required. To collect engineering-level three-dimensional measurements underwater, Hydro-Quebec developed the WireScan [2] [3], laser scanner for vertical surfaces that can achieve a  $\pm 1$ mm accuracy in still water. The system is portable and deployed from the deck, eliminating the need for divers (Figure 3).

Figure 3. WireScan measurements on a spillway. Underwater scanning (top right). Modular multifunctional platform (left).

WireScan uses two plumb lines as vertical references, maintaining high precision over the range (10 meters at La Gabelle). Supported by its tether, the laser camera slides vertically along wires stretched by weights. Each scan covers approximately 400 mm wide and is positioned in the 3D space with reference spheres measured with the ATS-600.
