Safety 360: Surround-View Sensing to Comply with Changes to the ISO 5006 Earth-Moving Machinery - Operator's Field of View - Test Method and Performance Criteria

J. Teizer ^a

^aRAPIDS Construction Safety and Technology Laboratory, Germany
E-mail: jochen@teizer.com

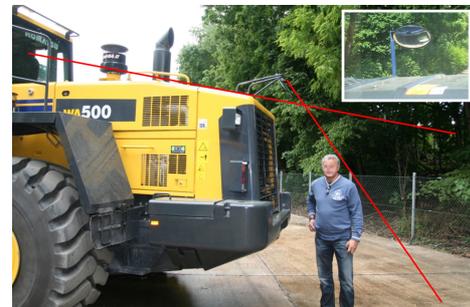
Figure 4. Ineffective use of mirrors in life-threatening proximity areas surrounding construction equipment (image courtesy [31])

Technological approaches are preferred over conventional techniques, such as, installing mirrors that do not function well when the height of engine compartments increases (partially due to new emission regulations) or the mirror mount vibrates while the equipment is in operation (see Figure 4). Legislation or leaders within companies, for example in the United Kingdom and Germany, have therefore demanded the installation of CCTV cameras in addition or as a replacement for using mirrors (see Figure 5).

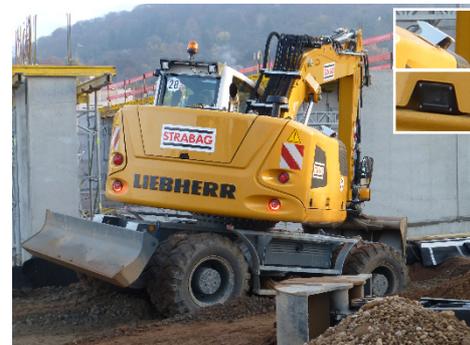
Figure 5. Large equipment manufacturers and contractors start installing and using vision-based monitoring technology on entire equipment fleets

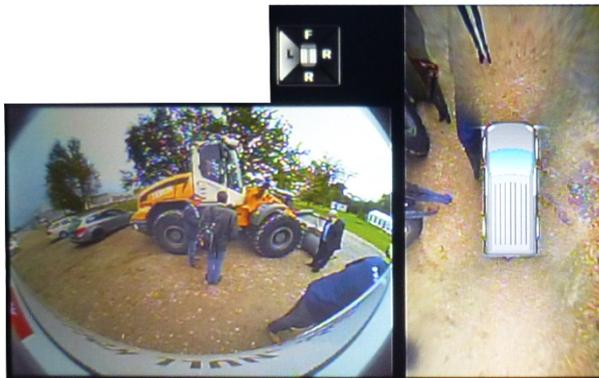
Figure 6. Surround-view (360°) providing equipment operator (here: a maintenance truck driver) with an on board bird's-eye-view of the areas around the vehicle

Emerging vision-camera solutions implement multiple cameras (4) and combine these to a so-called 360° views as shown in Figure 6. These allow an operator to view any nearby object projected in bird's-eye view on an in-cabin monitor (mounted typically on the dash board near the steering wheel). However, these systems require the operator to constantly monitor the screen, potentially distracting her/him from manually screening the surrounding spaces of the vehicle for workers-on-foot or other hazardous objects. As operators report frequently, these camera systems become useful in cases where the operator briefly checks the space a vehicle heads next.

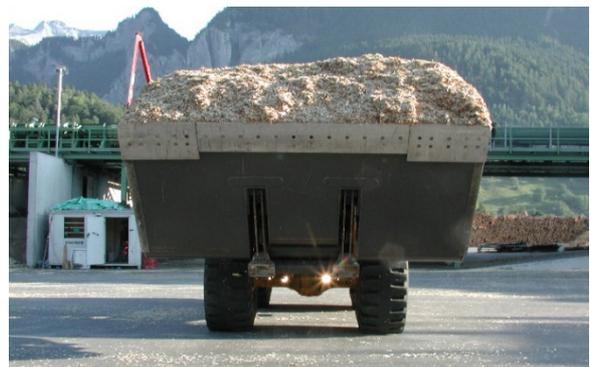
Figure 11. Lights brighten the space beneath the bucket (example: 13 m³ bucket for light material) of a wheel loader that is in a carry position

Alternatively, two bright light sources (see Figure 11) are proposed to provide enough illumination for the potentially darker spaces that are being covered by the bucket or any other attachment or load. See Figure 12 where the operator recognizes workers-on-foot through monitoring the screen that is provided inside the cabin.

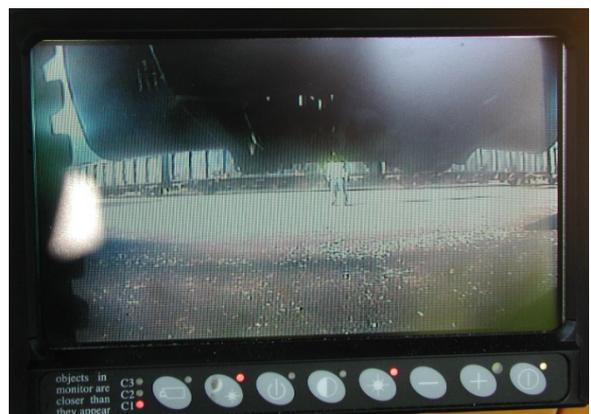
Figure 12. Operator field-of view to the front of a wheel loader as headlights illuminate the ground
