Transformation of Point Clouds to Images for Safety Analysis of Scaffold Joints

Jeehoon Kim¹, Sunwoong Paik¹, Yulin Lian¹, Juhyeon Kim¹, and Hyoungkwan Kim¹

¹Department of Civil and Environmental Engineering, Yonsei University, Korea

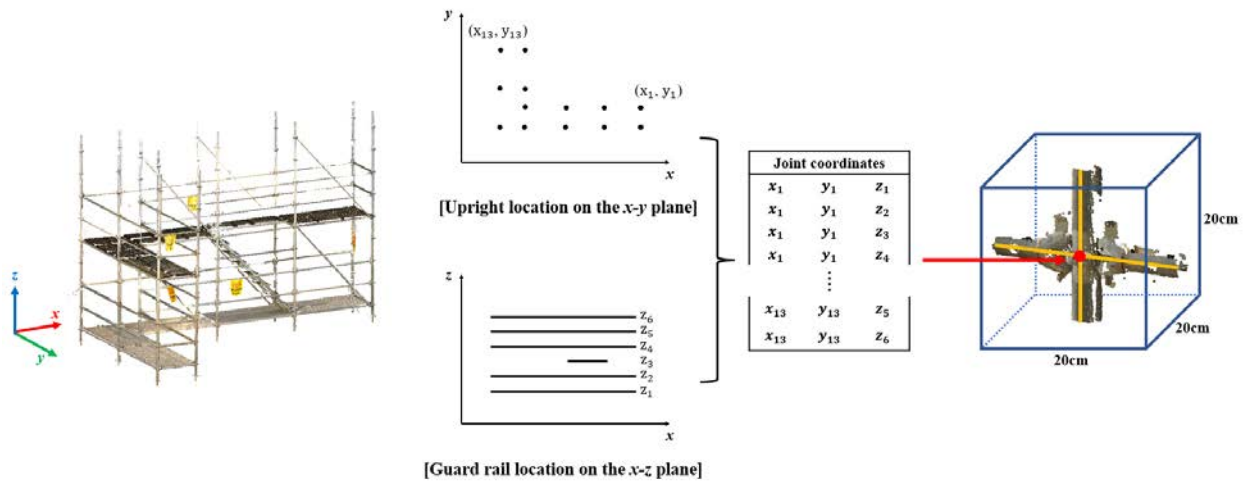
Figure 2. Joint extraction framework.

By using the algorithm from [5], we can obtain representative (x, y, z) coordinates of the “upright” and the “guard rail” in a scaffold. Combining these two information resulted in the intersection points of “upright” and “guard rail,” which is equal to the center coordinate of every joint. Afterwards, each joint coordinate is used as a center to crop a 20×20×20 (cm) sized bounding box from the point clouds, in order to extract the point cloud data for each joint. The joint extraction framework is shown in Figure 2. Then, the open-source library Open3D’s [10] Visualizer function is utilized to save the compressed appearance in the required viewpoint vector direction as an image for each joint point clouds. The required viewpoint vector varies depending on the type of joint. As shown in Figure 3, parallel joint (Figure 3(b)) generates one image from one viewpoint, while corner joint (Figure 3(c)) generates two images from two viewpoints.

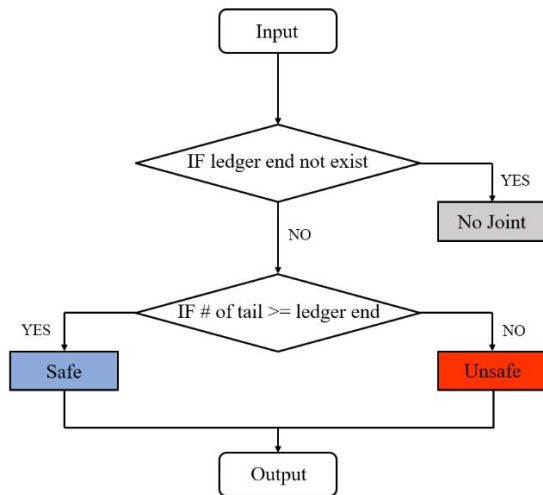
Figure 6. Rule-based joint safety classifier.

The safety status of each joint is inspected through the information of “ledger end” and “tail” detected through YOLOv5 in each image. If “ledger end” does not exist in an image (Figure 5(c)), the image is excluded from inspection because it does not have a joint. If “ledger end” exists, it indicates that a joint exists in the image and the number of detected “tail” and that of “ledger end” are compared. If the number of detected “tail” is less than that of “ledger end,” it is judged as unsafe because the “tail” is not visible (Figure 5(b)); there is a risk of accident due to incorrect insertion of pins and loose joints. In the case of a corner joint, if either of the two images of a single joint is classified as unsafe, then the joint is considered unsafe. The scenarios of safe, unsafe, and no joint are presented in Figure 5. The flowchart of the rule-based joint safety classifier is shown in Figure 6.
