APPLICATIONS OF COMPUTER VISION ONTILE ALIGNMENT INSPECTION

Keywords: Computer Vision, Tile Installation, Acceptance Procedure, Quality Assurance, Corner Detection

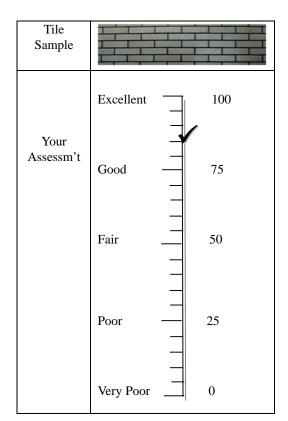
Figure 3. Expert Assessment Chart

To verify the accountability of the proposed system, the research team conducts a series of real jobsite tests. Our tests include two major parts: computer scoring, and expert scoring. The research team collects images of seven tile installation works and have the images processed and analyzed by the system to obtain their quality scores of alignment (computer scoring). For comparison purpose, we also organize an expert panel of 10 experienced professionals, including 2 jobsite managers, 7 masonry foremen, and 1 architect, to perform expert witness inspection. Experts are asked to mark their assessment on fuzzy scaled expert assessment charts of all seven works as shown in Figure 3. Mathematic average of 10 experts' assessment represents the witness inspection result (expert scoring). Table 2 summarizes the computer scoring and expert scoring results of the seven works.

A simple Pearson's Correlation test shows that the two scorings are highly correlated (Table 3), meaning computer scoring tends to yield a comparable result to expert scoring. These tests have proved that the proposed system has the potential to replace expert witness inspection for the scope of tile alignment.
