Development and Verification of Inspection Method for Concrete Surface utilizing Digital Camera

^a West Nippon Expressway Engineering Kansai Co.,Ltd., Japan

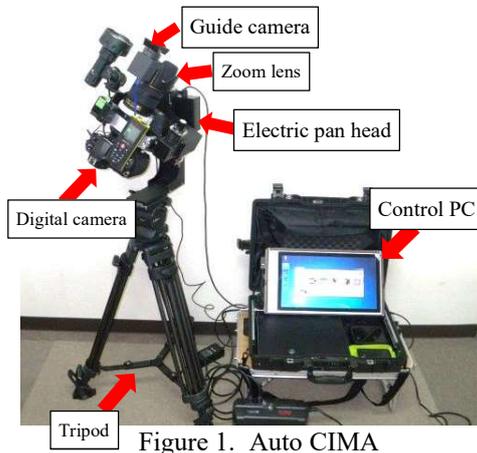
Auto CIMA can photograph concrete planes by automatically operating a digital camera with an electric pan head shown in Fig. 1 on a PC. The shooting range for one shot is $\pm 45^\circ$ on the long side and $\pm 30^\circ$ on the short side, and the dimensions differ depending on the shooting distance. The shooting plan (shooting angle of view and direction) shown in Figure 2 is automatically set by setting the shooting range and shooting accuracy (0.5mm/pixel in NEXCO West Japan) on the PC. This eliminates erroneous measurement during shooting as much as possible.

Figure 1. Auto CIMA

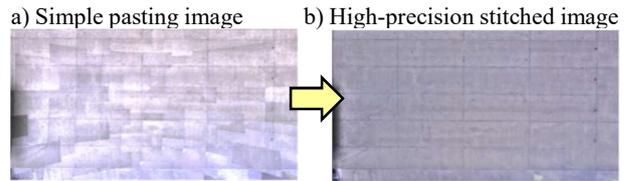
Auto-CIMA can easily check the shooting status of automatically shot images (Fig. 3 (a)). Images that are out of focus due to obstacles such as electric wires during automatic shooting can be re-shot with manual shooting. It is difficult to recognize as a single image due to the color unevenness of the image composition. Therefore, the captured images are stitched together with high precision by image processing. (Fig. 3(b)). Since this high-definition image composition requires processing on a high-performance PC, it is performed indoors rather than immediately after shooting.

Figure 3. Automatic stitching image
