DEVELOPMENT OF LASER SCANNING SYSTEM FOR AGING INSPECTION OF BOX CULVERT

Sang Kyun Woo^{1*}, Jong Sung Kim², Jun Hyung Jo¹, and Young Chul Song¹

¹ Green Growth Laboratory, KEPCO Research Institute, Daejeon, Korea

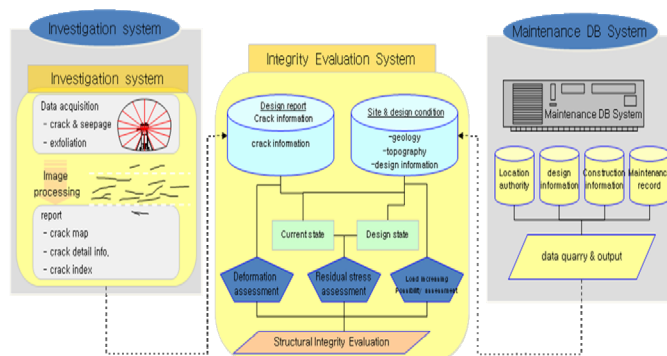
Fig. 1 Outline of Structural Integrity Evaluation System

The system developed in this study is composed of three parts: a diagnostic system using a 3D optical scanner; a maintenance DB system managing the aging and repair history data of box culvert; and a structural integrity evaluation system that executes integrity evaluation utilizing data collected from the diagnostic and maintenance DB system (Fig. 1).

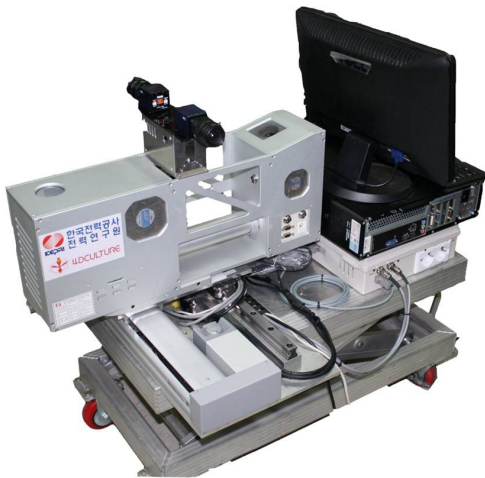
Fig. 2 Aging Inspection System of Box Culvert

following: obtaining 3D image data, lining up and matching the obtained 3D images, measurement based on actual 3D coordinates, and input/output system related to data management and storage. The development of the 3D image data obtaining system can be divided into scanning system development using a laser slit beam and optical 3D scanning system development. The optical scanner of this system is a 3D scanner based on the space encoding method that uses a pattern beam. Its scan range is 400×300mm, degree of precision less than 0.1mm, and scan cycle time less than 1 second (Fig. 2).
