GEOMETRIC EVALUATION OF ROAD SIGNS USING RADIOMETRIC INFORMATION FROM LASER SCANNING DATA

Department of Natural Resources and Environmental Engineering. University of Vigo, Vigo, Spain

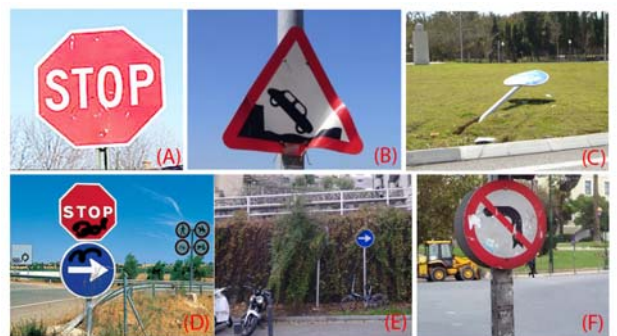
Fig. 2. Different examples of damages in traffic signs: (A) paint deterioration, (B) folded sheet, (C) pole bent, (D) vandalism, (E) concealment by vegetation and (F) adhered substances.

Figure 2 shows an example of different traffics signs and their associated damages.

The plane fitted to the traffic signs also gives important information about the condition state of the sign. Standard deviation values give evidence about the flatness of the sign sheet (Table 2). Figure 11 shows a sign (sign 7) with a folded sheet (Fig. 2 B) which results in a high standard deviation. A similar behavior is also depicted by sign 9.

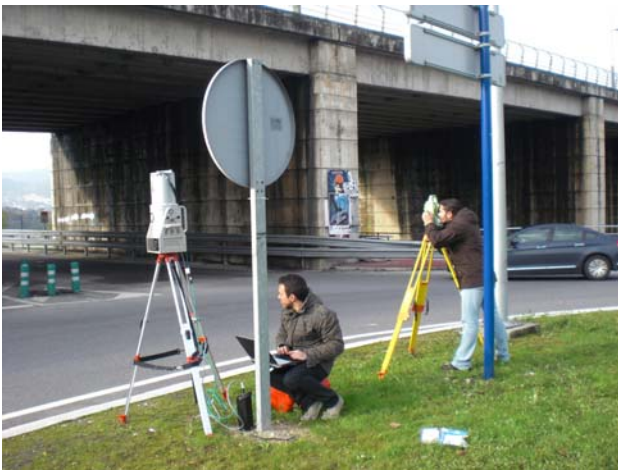
Fig. 3. RIEGL LMS Z390i during surveying process.

The terrestrial laser scanning system RIEGL LMS-Z390i is composed of an accurate and fast 3D scanner with the associated software RISCAN PRO. The RIEGL LMS-Z390i (Figure 3) is a rugged and fully portable sensor especially designed for the rapid and accurate acquisition of high-quality three dimensional images and particularly indicated for architecture and façade measurement, archaeology and cultural heritage documentation, civil engineering, city modeling and surveying.

Measurements are performed using the time of flight principle for range and two encoders for angular evaluation. Time of flight scanners use a diode pumped laser and the distance is based on the return flight time of each laser beam. There are other technologies in the market based on the phase difference of the coming beam. Time of flight scanners are more indicated for long ranges, but they have a higher signal to noise ratio in short and medium range. Precision mechatronics systems are used for positioning the mirrors which orientate the laser beam to the measuring field. A rotating mirror with 90° travel is used for vertical measurement and a servo motor that rotates 360° allows the horizontal scanning. The point cloud obtained from the Spherical coordinates (R, θ, ϕ) is then directly converted into Cartesian coordinates (X, Y, Z) by the software. Furthermore, the laser scanner used in this experiment includes an infrared class 1 laser which means that is

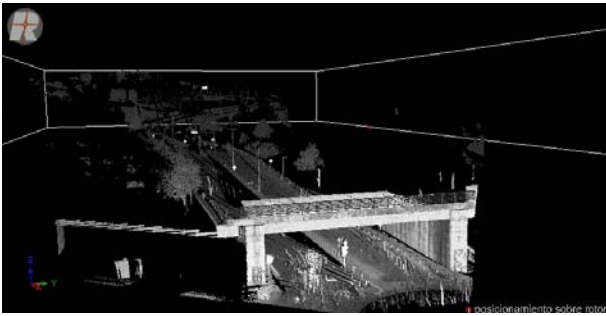
Figure 5. Detailed scan.

The second step is to perform a detailed scan (Figure 5) of the highway entrance. Scan characteristics are a step-width of 0.04° , 1.986.892 measured points and $8' 23''$ of time.
