# APPLICATIONS OF COMPUTER VISION ON TILE ALIGNMENT INSPECTION

Kuo-Liang Lin\* and Jhih-Long Fang

*Department of Civil and Ecological Engineering, I-Shou University, Kaohsiung, Taiwan*

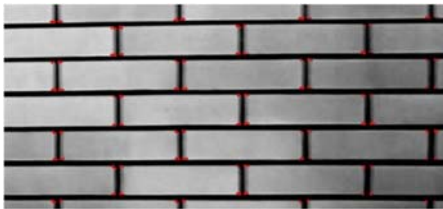
Corner detection is an approach used within computer vision systems to extract corners for subsequent processing, and a corner can be defined as the intersection of two edges. Since we use tile corner deviation to judge tile alignment quality, it is important to extract tile corners from the image. We use a heuristic corner detector “FAST” developed by Rosten [8] as the extracting tool, and store the corner coordinates in a text file (Figure 2).

Figure 2. Corners detected by Rosten’s FAST

There should be only one point at each tile corner. However, motion blurs from inevitable camera shake result in hazy corners so that corner detection usually yields multiple points at each corner (as in Fig. 2). It is necessary to converge these multiple coordinates into one single point to represent the exacted corner. We write a Visual Basic subroutine and run all points extracted from corner detector through it to obtain a single set of corner coordinates. This corner convergence subroutine collects all neighboring points surround each corner and converges all into one single set of coordinate representing the corner. This routine also purges the noise away from the corners. Next step is to classify all corner points into sub groups by each horizontal and vertical line, and this step is called “corner clustering”. The points that are supposed to be aligned to the same horizontal line have adjacent  $y$ -coordinates and the points that are supposed to be aligned

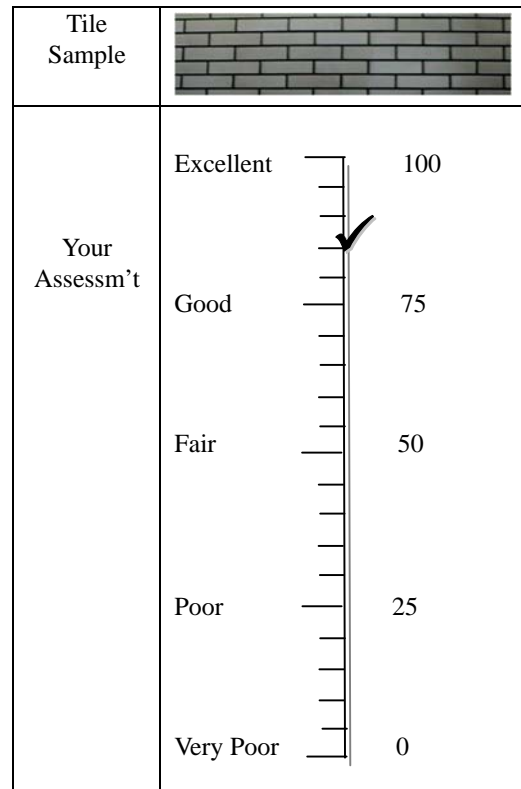
alignment (computer scoring). For comparison purpose, we also organize an expert panel of 10 experienced professionals, including 2 jobsite managers, 7 masonry foremen, and 1 architect, to perform expert witness inspection. Experts are asked to mark their assessment on fuzzy scaled expert assessment charts of all seven works as shown in Figure 3. Mathematic average of 10 experts' assessment represents the witness inspection result (expert scoring). Table 2 summarizes the computer scoring and expert scoring results of the seven works.

Figure 3. Expert Assessment Chart
